Performance Monitoring Development for Impoundment Removal Projects

Bree Stephens

June 2024

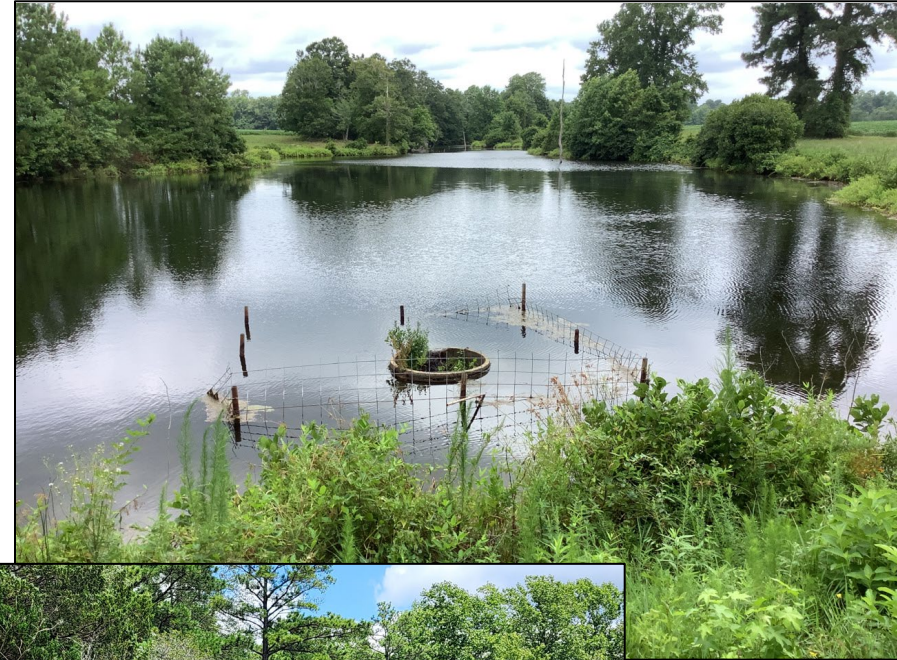
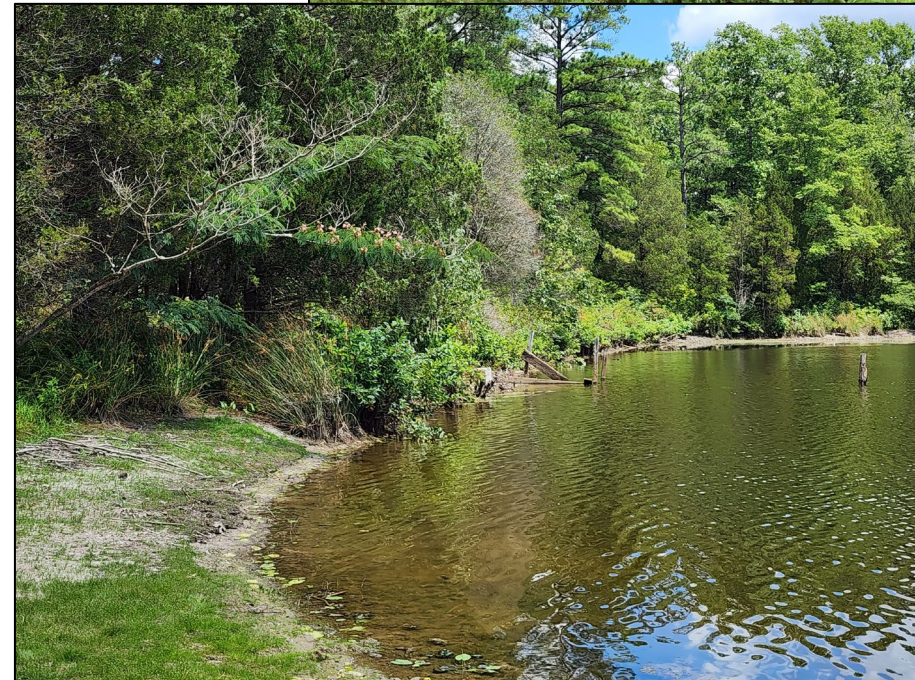
Impoundment Removal Projects in Virginia

- Two Clean Water Act (CWA) 404 mitigation projects in Virginia:
 - One Permittee Responsible Mitigation (PRM) – Preparing to go to construction
 - One through The Nature Conservancy Virginia Aquatic Resources Trust Fund (VARTF) – Waiting on comments on the concept site development plan
- Both are small headwater systems in the Coastal Plain of Virginia with earthen dams.
- Design plan for both projects is to remove the earthen dams, grade a pilot channel through the dam footprint, and allow the channels to reestablish through natural hydraulic and geomorphic processes within the old pond bottom.

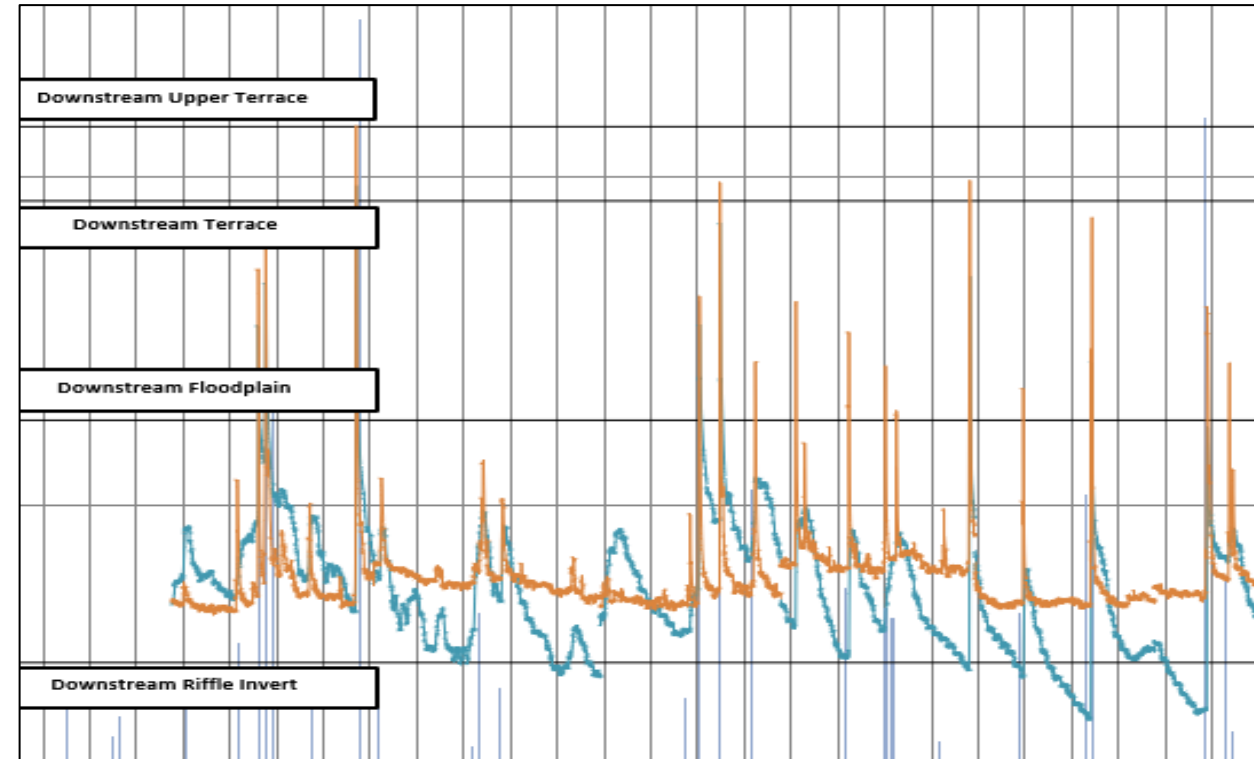
Floodplain Connectivity

- Stream gage measuring flood events – direct measurement
- Photos of flood evidence - indirect

- *Flows do not exceed top of bank at least once per year*

- Graphs, # floods per year, photos

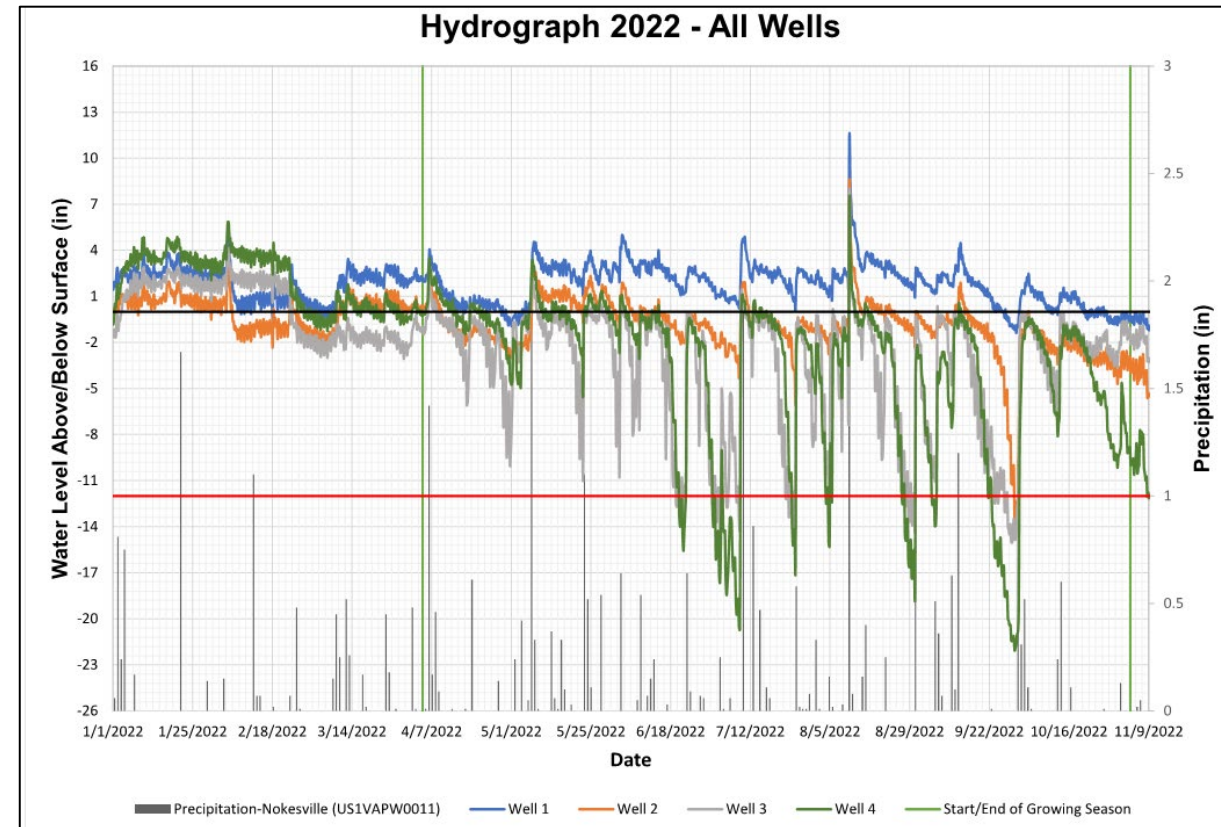
Groundwater and Surface Water Exchange

- Groundwater Wells in floodplain

- *Groundwater is not within 18 inches of surface elevation within floodplain for more than 30 days in the growing season in years of average or wetter rainfall*

- Graphs and associated tables

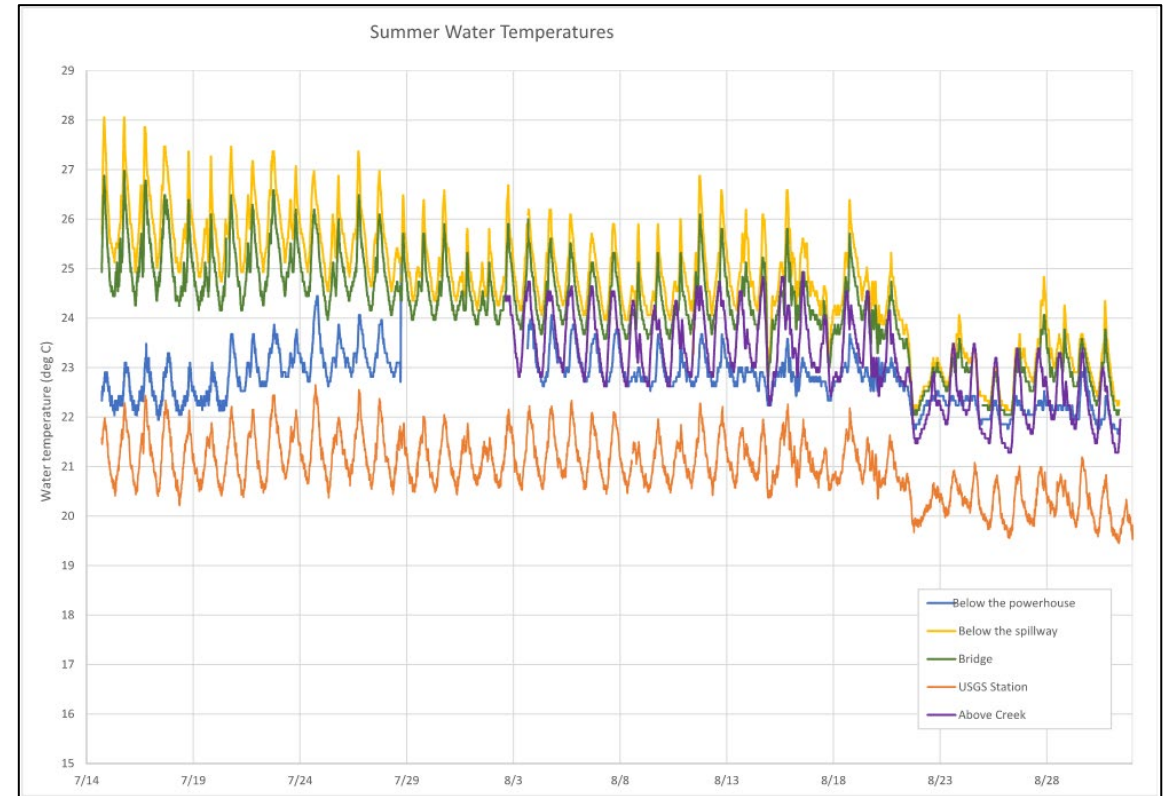
- Temperature loggers set pre-construction, reset post-construction

- *Surface water temperatures are above pre-project values*

- Graph comparing pre- and year to year

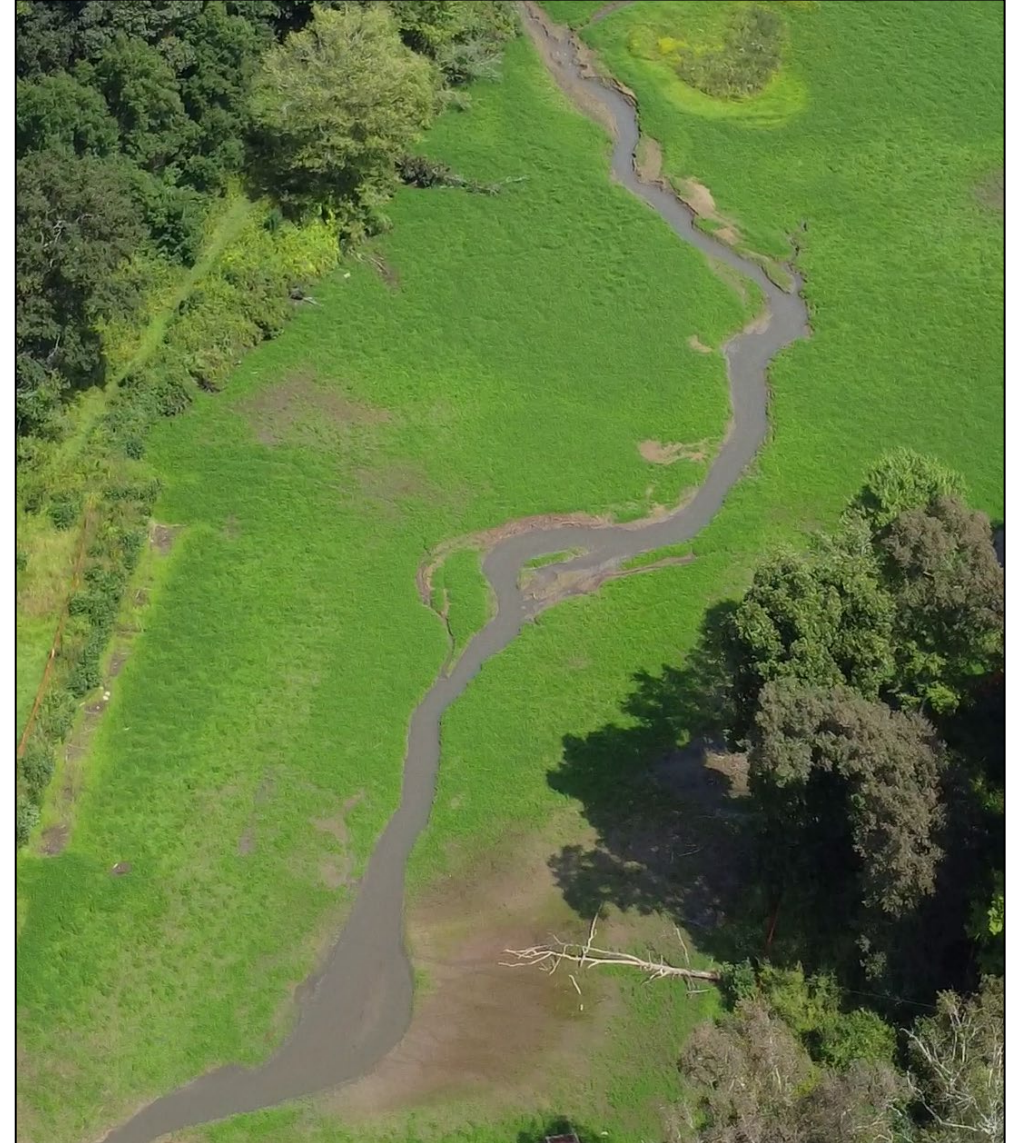
Stream Channel Formation

- Aerial photos taken quarterly in first year, winter aerial photos each monitoring year

- *Identifiable channels do not develop*

- Aerial with top of bank lines drawn and year to year comparisons
